**Flood Control Project Maintenance
Levee Inspections****LMA District Cover Sheet****Spring 2014 Levee Inspection Results****Reclamation District No. 1000 Natomas**

Spring 2014 Levee Inspection Results

Reclamation District No. 1000 Natomas

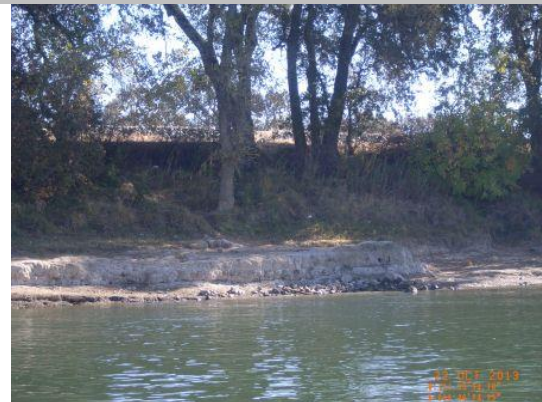
Photo 1 of 1 : USACE2013A_SAC_78-3_L_7.jpg

LM Start	0.51	Rating **	M	Issue No.	3
LM End	0.61	Issue Type +	Ma	Location *	WS
Category	Supplemental			GPS Latitude/Longitude	
				Start	End
Item	USACE Erosion Survey			38.774507 °	38.772921 °
				-121.598865 °	-121.597788 °
DWR ID					
Action/Comments					
Inspector Comments: 1997 - Very cohesive toe. 2005 - Site was staked and rock was stockpiled along the top of the bank. 2010 - New adjacent levee under construction. 2011 - New animal burrow. 2013: No observed changes. [2013 Site ID: SAC_78-3_L]

USACE 2013 Photo #1

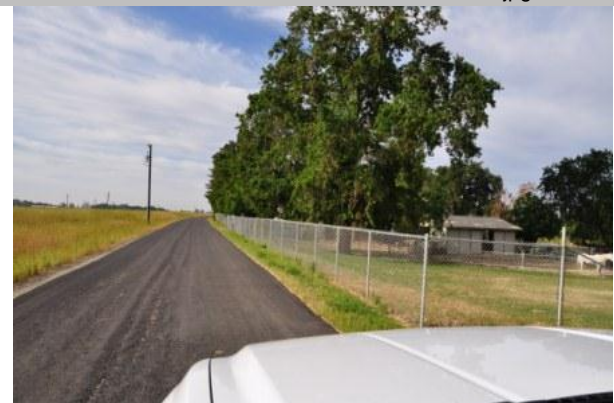
Photo 1 of 1 : mhoffman_s_20140402_412.jpg

LM Start	1.65	Rating **	U	Issue No.	136
LM End	1.65	Issue Type +	En	Location *	WS
Category	Earthen Levee			GPS Latitude/Longitude	
				Start	End
Item	Encroachments			38.759320 °	38.759320 °
				-121.591343 °	-121.591343 °
DWR ID	DWR_RD1000_01_s _ 2012_136				
Action/Comments					
Fence

Unauthorized encroachment, 'Fence'

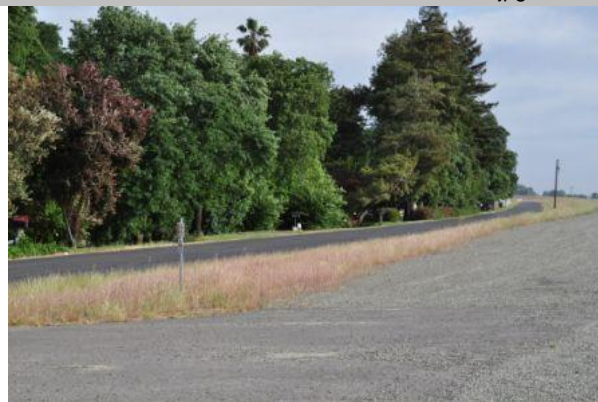
Photo 1 of 1 : mhoffman_s_20140402_411.jpg

LM Start	1.88	Rating **	M	Issue No.	133
LM End	1.91	Issue Type +	En	Location *	WS
Category	Earthen Levee			GPS Latitude/Longitude	
				Start	End
Item	Vegetation			38.755975 °	38.755585 °
				-121.591433 °	-121.591530 °
DWR ID	DWR_RD1000_01_s _ 2012_133				
Action/Comments					
Landscaping

Typical Garden Hwy 'Landscaping'

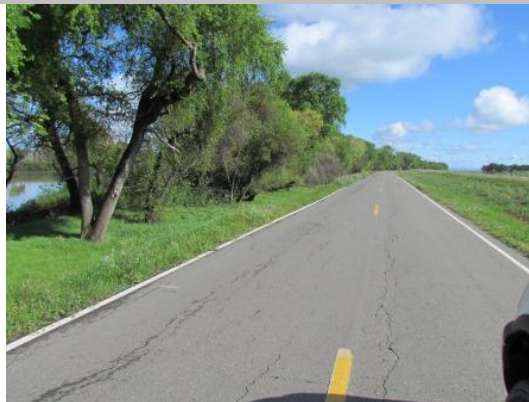
Photo 1 of 1 : mhoffman_s_20140403_419.jpg

LM Start	3.21	Rating **	M	Issue No.	18
LM End	3.21	Issue Type +	Ma	Location *	WS
Category	Earthen Levee			GPS Latitude/Longitude	
				Start	End
Item	Vegetation			38.738601 °	38.738601 °
				-121.600662 °	-121.600662 °
DWR ID	DWR_RD1000_01_s _ 2014_18				
Action/Comments					
Control annual grass and weeds on the levee slopes and easements.

This photo was taken from the crown facing north looking at annual vegetation on the waterward levee slope. Spring 2014.

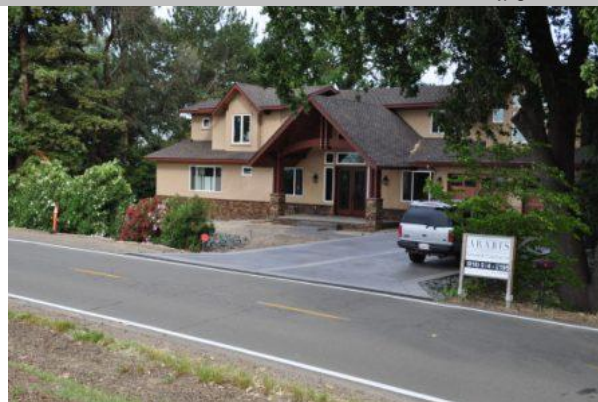
Photo 1 of 1 : mhoffman_s_20140402_408.jpg

LM Start	6.57	Rating **	M	Issue No.	17
LM End	6.57	Issue Type +	En	Location *	WS
Category	Earthen Levee			GPS Latitude/Longitude	
				Start	End
Item	Encroachments			38.698179 °	38.698179 °
				-121.628077 °	-121.628077 °
DWR ID	DWR_RD1000_01_s _ 2012_17				
Action/Comments					
Building

Newly Constructed Home

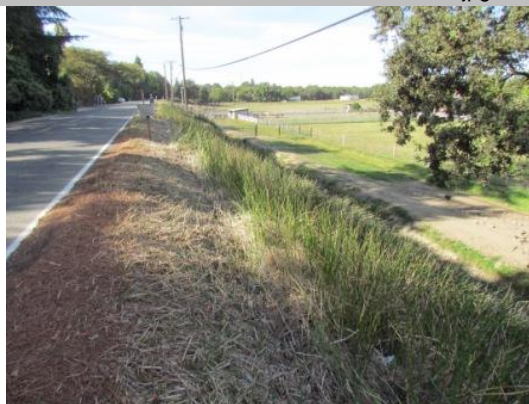
Photo 1 of 1 : mhoffman_s_20140402_407.jpg

LM Start	13.31	Rating **	M	Issue No.	12
LM End	14.01	Issue Type +	Ma	Location *	LS
Category	Earthen Levee			GPS Latitude/Longitude	
				Start	End
Item	Vegetation			38.641163 °	38.631303 °
				-121.562661 °	-121.560729 °
DWR ID	DWR_RD1000_01_f _ 2013_12				
Action/Comments					
Control annual grass and weeds on the levee slopes and easements.

This photo was taken from the crown of the levee facing west looking at the joint grass on the landward slope.

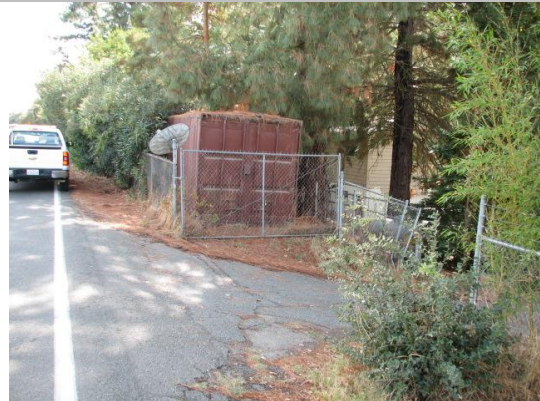
Photo 1 of 1 : mhoffman_s_20140402_409.jpg

LM Start	15.35	Rating **	M	Issue No.	76
LM End	15.35	Issue Type +	En	Location *	WS
Category	Earthen Levee			GPS Latitude/Longitude	
				Start	End
Item	Encroachments			38.612340 °	38.612340 °
				-121.558633 °	-121.558633 °
DWR ID	DWR_RD1000_01_f_2012_76				
Action/Comments					
Building

Levee mile 15.35, cargo container on levee shoulder, the property appears to be on fill material.

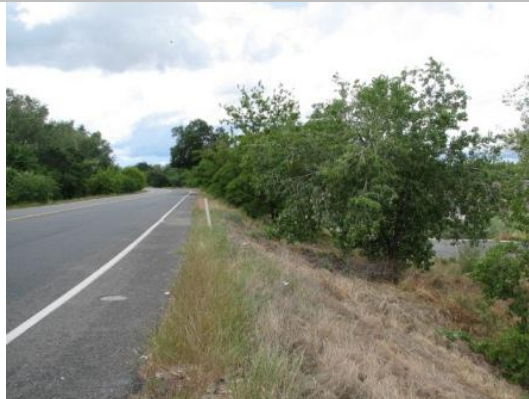
Photo 1 of 2 : mhoffman_s_20140402_403.jpg

LM Start	0.56	Rating **	M	Issue No.	1
LM End	2.33	Issue Type +	En	Location *	LS
Category	Earthen Levee			GPS Latitude/Longitude	
				Start	End
Item	Encroachments			38.607549 °	38.605980 °
				-121.501797 °	-121.470627 °
DWR ID	DWR_RD1000_02_s _ 2012_1				
Action/Comments					
Urban

Landside encroachment, landscaping, levee mile 1.68.

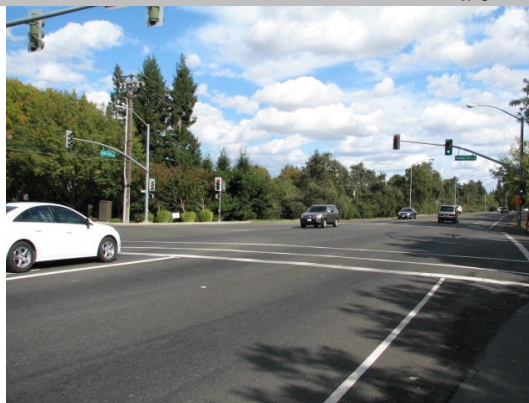
Photo 2 of 2 : mhoffman_s_20140402_404.jpg

LM Start	0.56	Rating **	M	Issue No.	1 (cont)
LM End	2.33	Issue Type +	En	Location *	LS

Levee mile 0.56. This photo is looking upstream from the waterside levee shoulder to the landside shoulder.

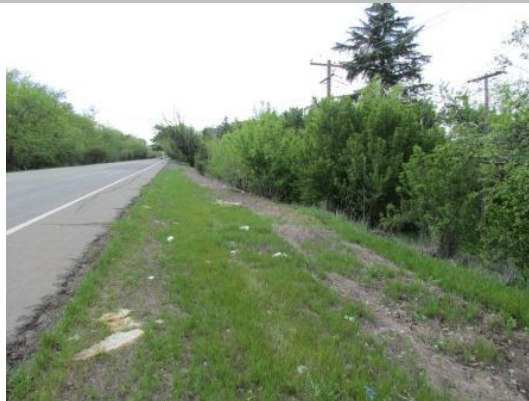
Photo 1 of 1 : mhoffman_s_20140415_432.jpg

LM Start	1.54	Rating **	M	Issue No.	2
LM End	1.54	Issue Type +	Ma	Location *	LS
Category	Earthen Levee			GPS Latitude/Longitude	
				Start	End
Item	Trim / Thin Trees			38.607978 °	38.607978 °
				-121.483858 °	-121.483858 °
DWR ID	DWR_RD1000_02_s _ 2014_2				
Action/Comments					
Thin trees to allow visibility of the ground and room to flood fight.

This photo was taken from the crown facing west looking down the landward levee slope at trees requiring maintenance. Spring 2014.

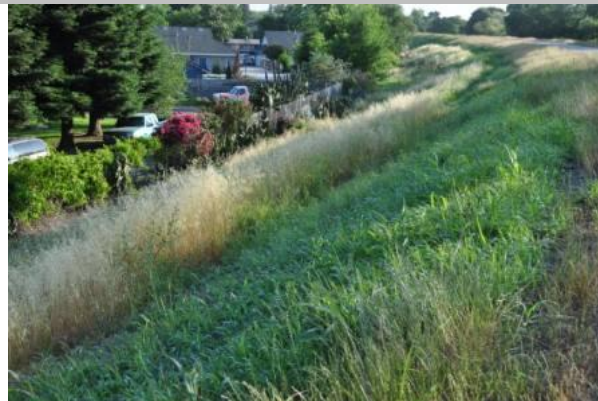
Photo 1 of 1 : mhoffman_s_20140402_415.jpg

LM Start	0.07	Rating **	M	Issue No.	7
LM End	0.13	Issue Type +	En	Location *	LS
Category	Earthen Levee			GPS Latitude/Longitude	
				Start	End
Item	Encroachments			38.606882 °	38.607523 °
				-121.469480 °	-121.469033 °
DWR ID	DWR_RD1000_03_s _ 2012_7				
Action/Comments					
Fence

Fence with vegetation at L/S toe.

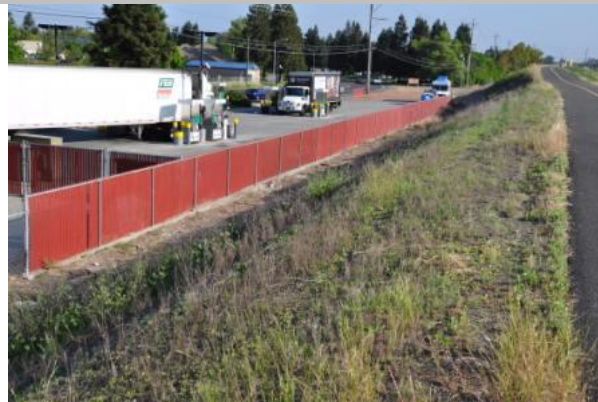
Photo 1 of 1 : mhoffman_s_20140402_414.jpg

LM Start	3.05	Rating **	M	Issue No.	3
LM End	3.10	Issue Type +	En	Location *	LS
Category	Earthen Levee			GPS Latitude/Longitude	
				Start	End
Item	Encroachments			38.648677 °	38.649412 °
				-121.474882 °	-121.475005 °
DWR ID	DWR_RD1000_03_s_2012_3				
Action/Comments					
Fence

Fence within 10' of L/S toe.

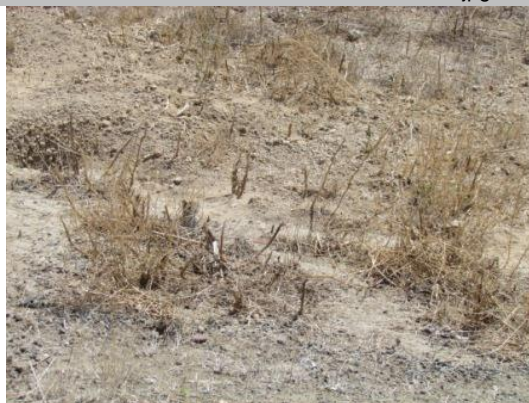
Photo 1 of 2 : mhoffman_s_20140402_413.jpg

LM Start	4.85	Rating **	A/W	Issue No.	1
LM End	4.96	Issue Type +	Ma	Location *	LS
Category	Earthen Levee			GPS Latitude/Longitude	
				Start	End
Item	Animal Control			38.672913 °	38.673685 °
				-121.481364 °	-121.483115 °
DWR ID	DWR_RD1000_03_f_2013_1				
Action/Comments					
Exterminate rodents and backfill and compact or grout burrows.

This photo was taken from the levee crown looking down the landward slope at a squirrel poking its head out of a hole.

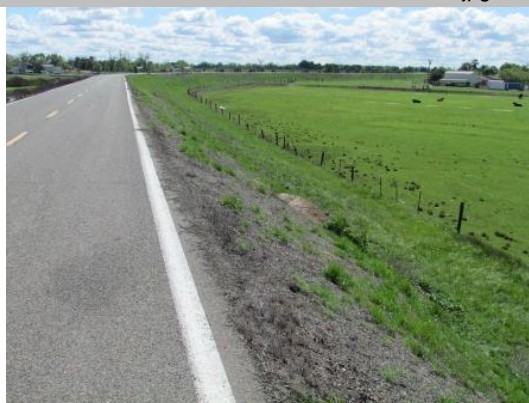
Photo 2 of 2 : mhoffman_s_20140415_433.jpg

LM Start	4.85	Rating **	A/W	Issue No.	1 (cont)
LM End	4.96	Issue Type +	Ma	Location *	LS

This photo was taken from the crown facing south looking down the landward slope at a rodent hole requiring maintenance. Spring 2014.

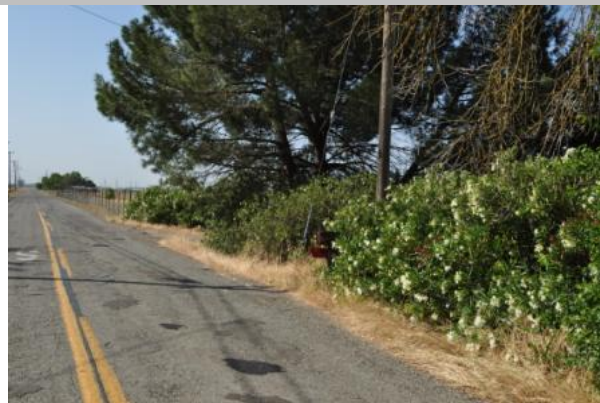
Photo 1 of 1 : mhoffman_s_20140402_418.jpg

LM Start	12.54	Rating **	M	Issue No.	13
LM End	12.54	Issue Type +	En	Location *	LS
Category	Earthen Levee			GPS Latitude/Longitude	
				Start	End
Item	Vegetation			38.779083 °	38.779083 °
				-121.500392 °	-121.500392 °
DWR ID	DWR_RD1000_03_s_2012_13				
Action/Comments					
Landscaping

L/S landscaping.

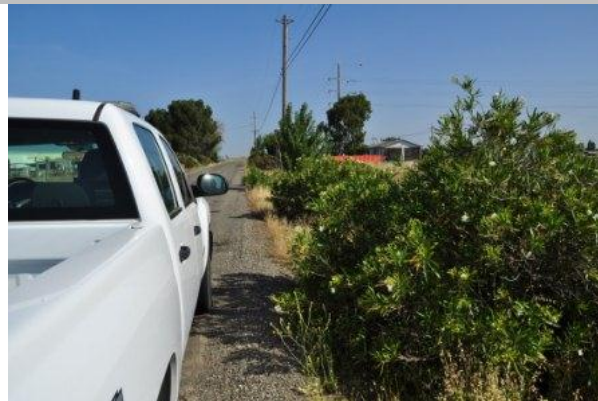
Photo 1 of 1 : mhoffman_s_20140402_417.jpg

LM Start	12.54	Rating **	M	Issue No.	10
LM End	12.63	Issue Type +	En	Location *	WS
Category	Earthen Levee			GPS Latitude/Longitude	
				Start	End
Item	Vegetation			38.779037 °	38.779505 °
				-121.500397 °	-121.500955 °
DWR ID	DWR_RD1000_03_s _ 2012_10				
Action/Comments					
Landscaping

W/S vegetation.

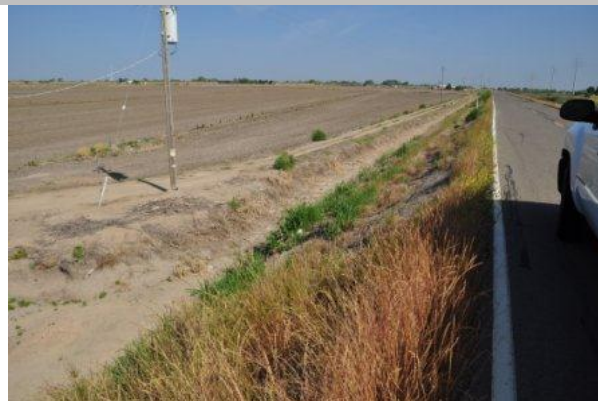
Photo 1 of 1 : mhoffman_s_20140402_416.jpg

LM Start	15.51	Rating **	M	Issue No.	9
LM End	16.07	Issue Type +	En	Location *	LS
Category	Earthen Levee			GPS Latitude/Longitude	
				Start	End
Item	Encroachments			38.816259 °	38.823314 °
				-121.522787 °	-121.526942 °
DWR ID	DWR_RD1000_03_s _ 2012_9				
Action/Comments					
Ditch

L/S Ag ditch @ L/S toe.

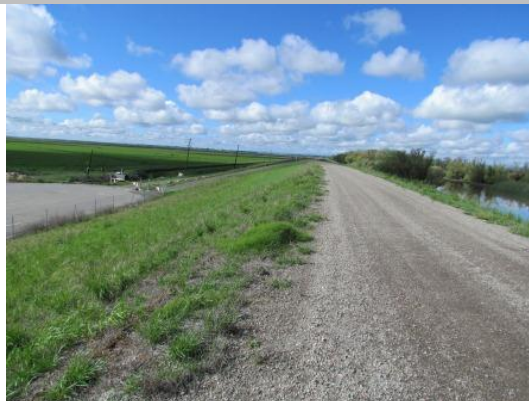
Photo 1 of 1 : mhoffman_s_20140407_420.jpg

LM Start	0.17	Rating **	M	Issue No.	1
LM End	0.17	Issue Type +	Ma	Location *	LS
Category	Earthen Levee			GPS Latitude/Longitude	
				Start	End
Item	Vegetation			38.818995 °	38.818995 °
				-121.546089 °	-121.546089 °
DWR ID	DWR_RD1000_04_s _ 2014_1				
Action/Comments					
Control annual grass and weeds on the levee slopes and easements.

This photo was taken from the crown facing east looking down the land ward levee slope at annual vegetation growth prior to maintenance. Spring 2014.
